Re: Madison High School Stadium
Marshall, NC
(KEPA No. 20220110)

Kloesel Engineering, P.A. (KEPA) has visually observed the existing stadium bleachers and presents this letter as a summary of our observations and recommendations.

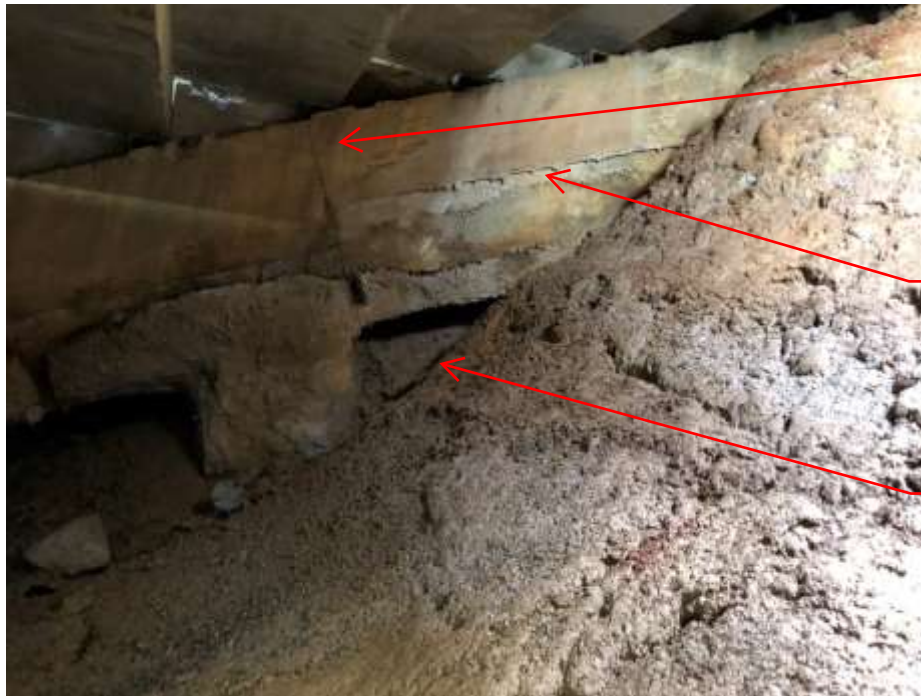
Photo 1

Vertical crack in concrete grade beam

Possible location of original soil, now eroded

Soil erosion from beneath grade beam

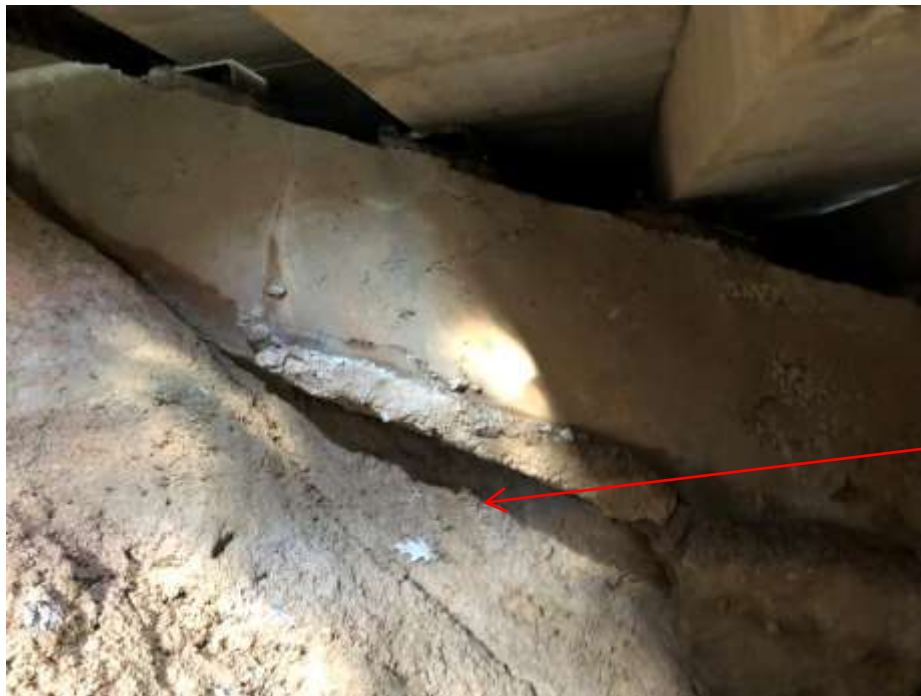
Photo 2

Soil erosion from beneath grade beam

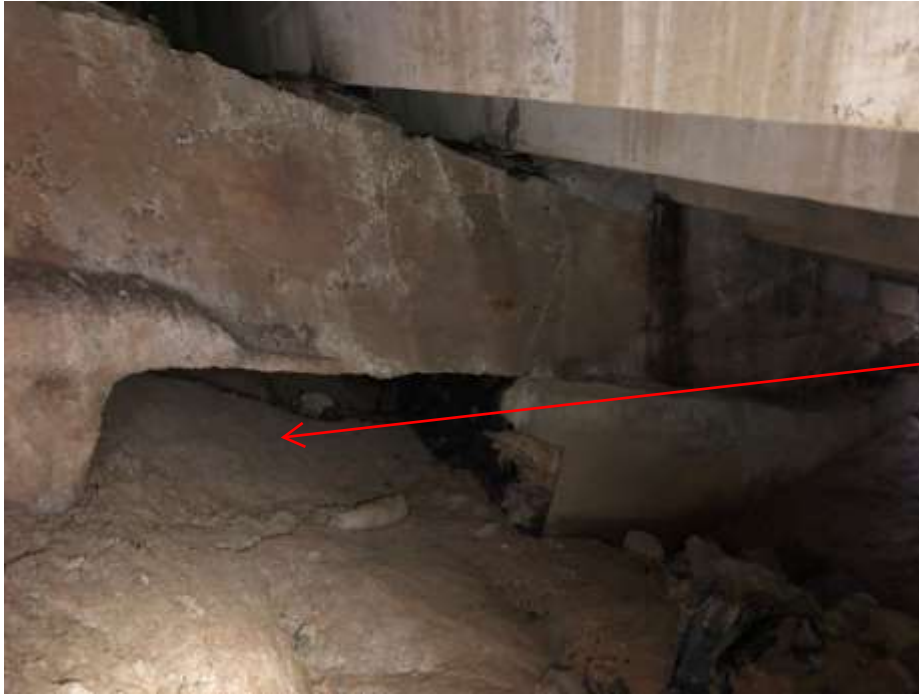
Photo 3

Soil erosion from beneath
grade beam

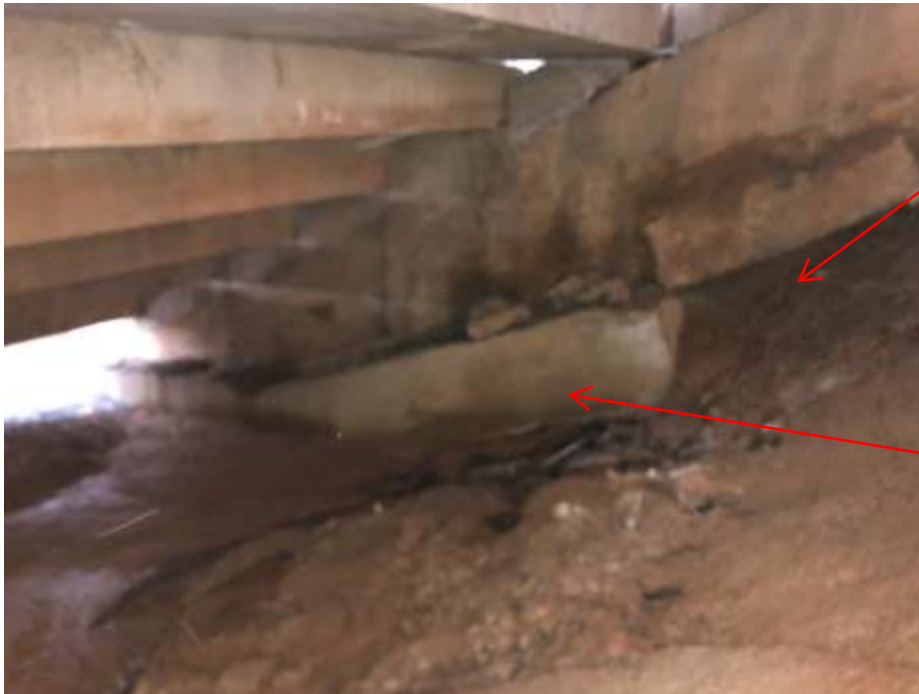
Photo 4

Soil erosion from beneath
grade beam

Concrete from previous
repair

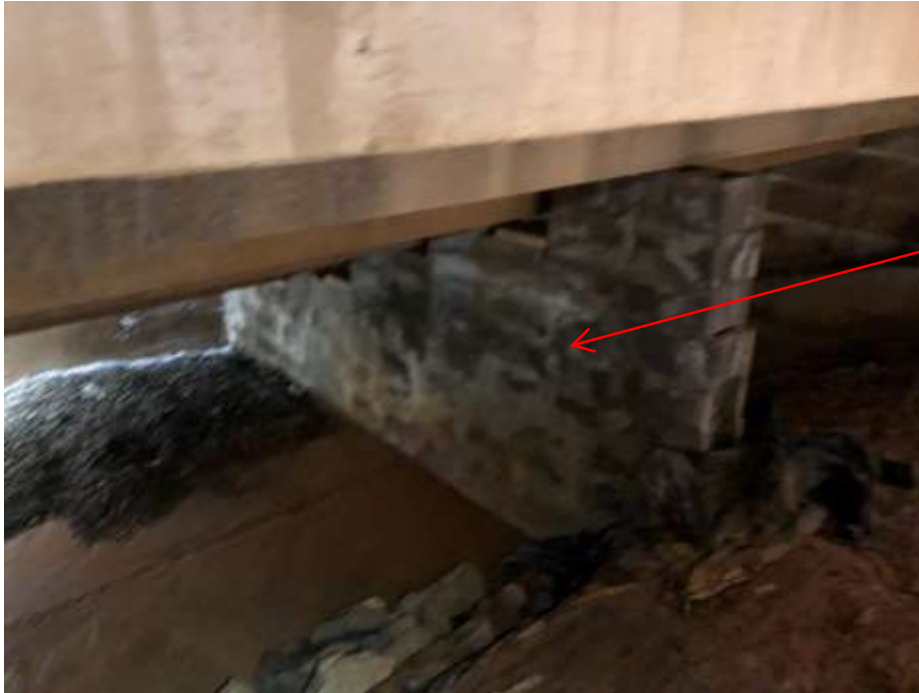
Photo 5

CMU wall from previous repair

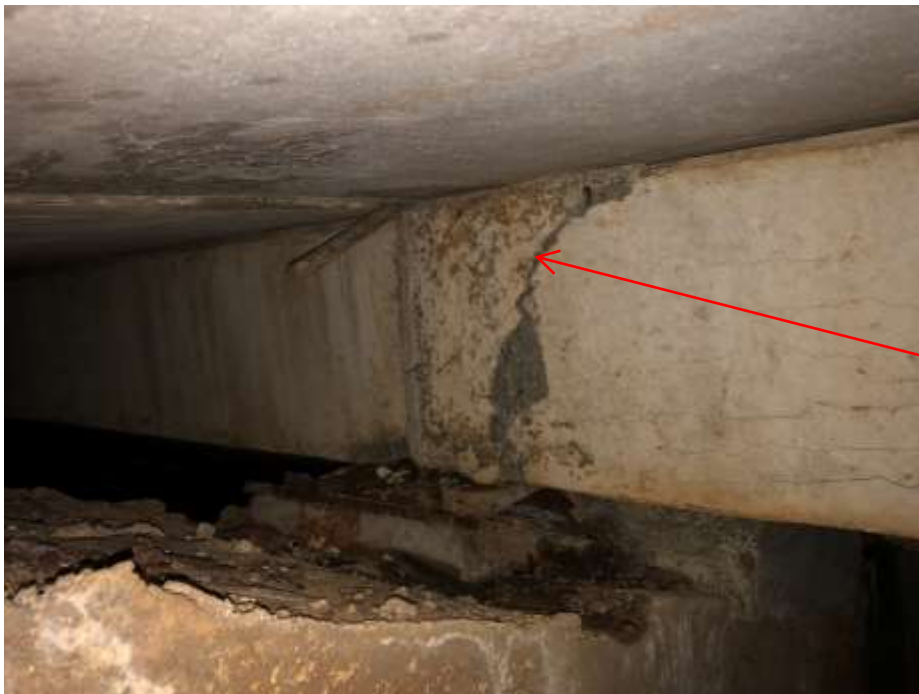
Photo 6

Crack in precast concrete beam

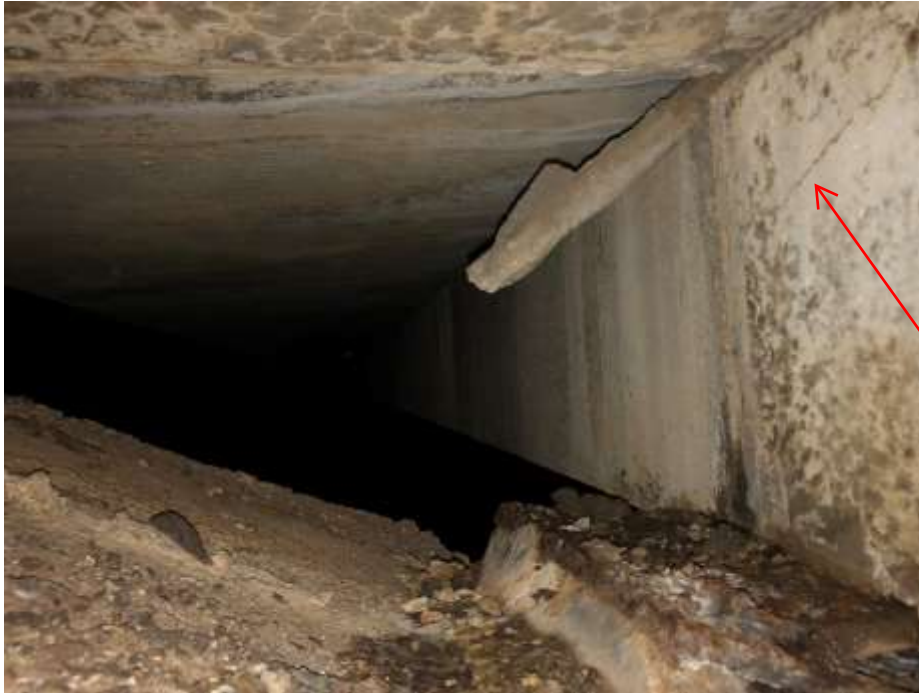
Photo 7

Crack in precast concrete beam

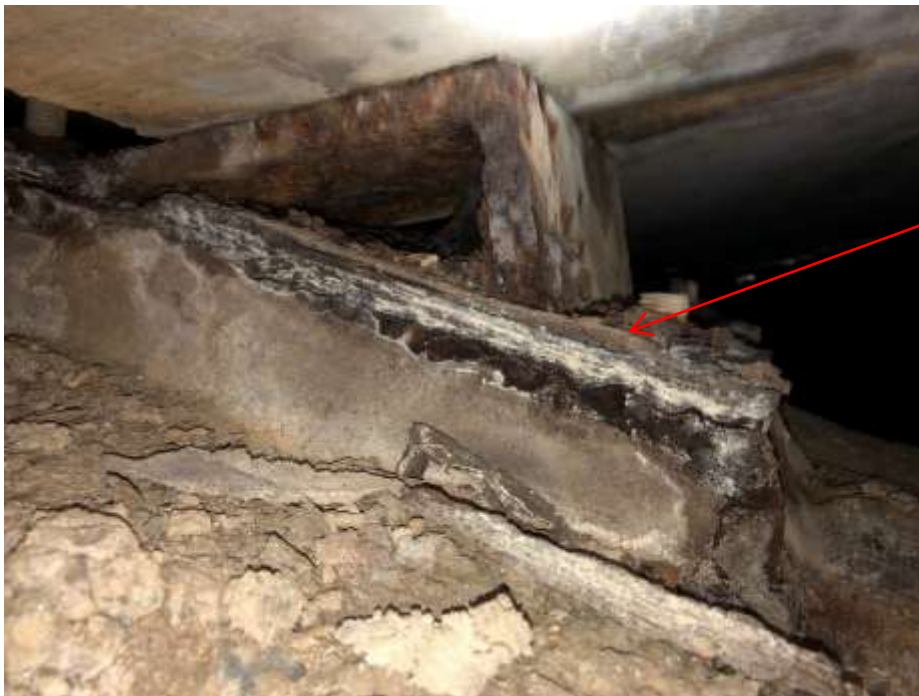
Photo 8

Corrosion in steel support bracket

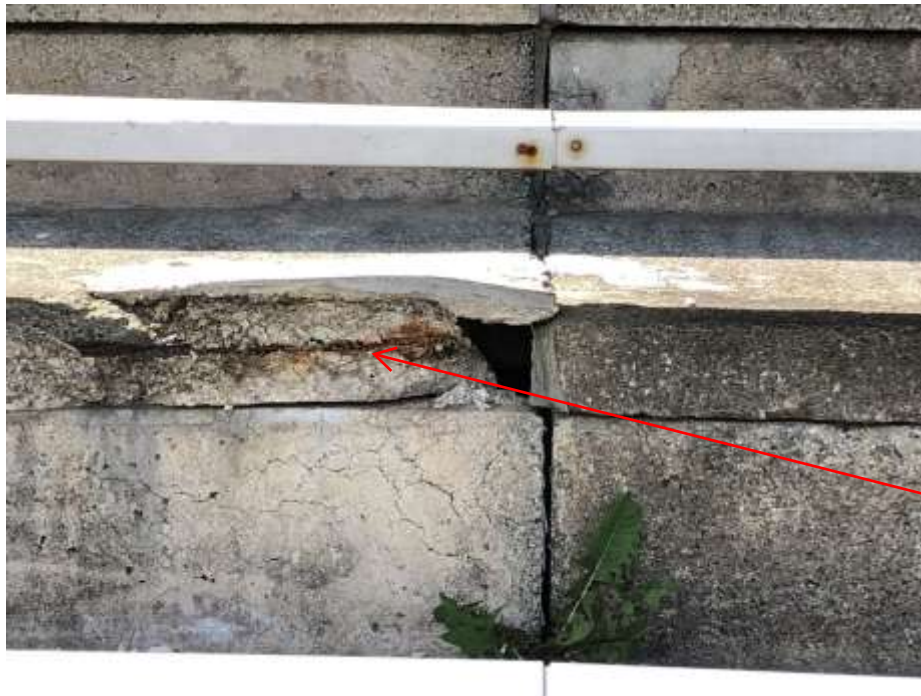
Photo 9

Spalled Concrete

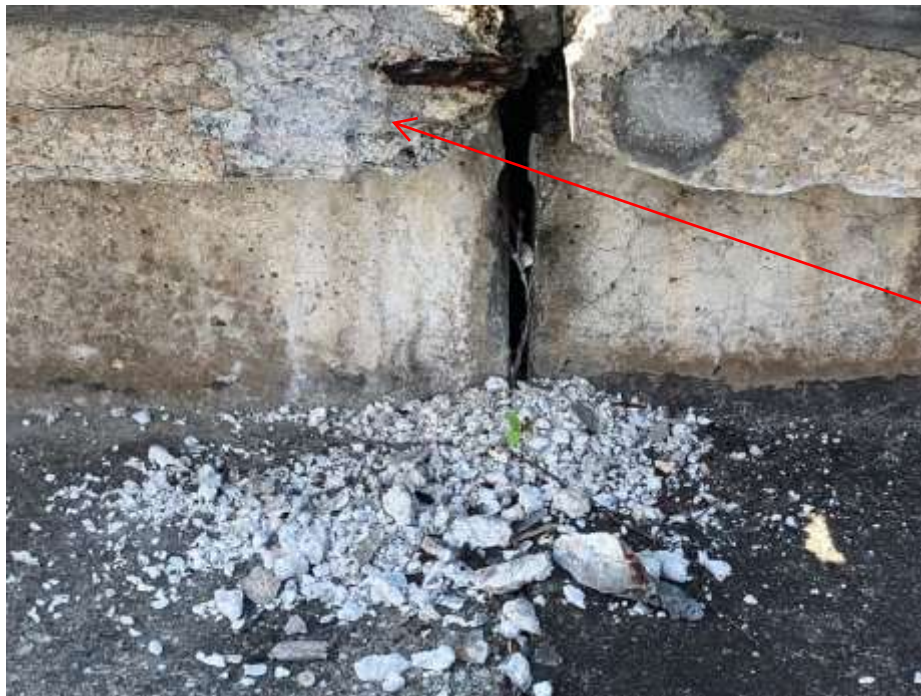
Photo 10

Spalled Concrete

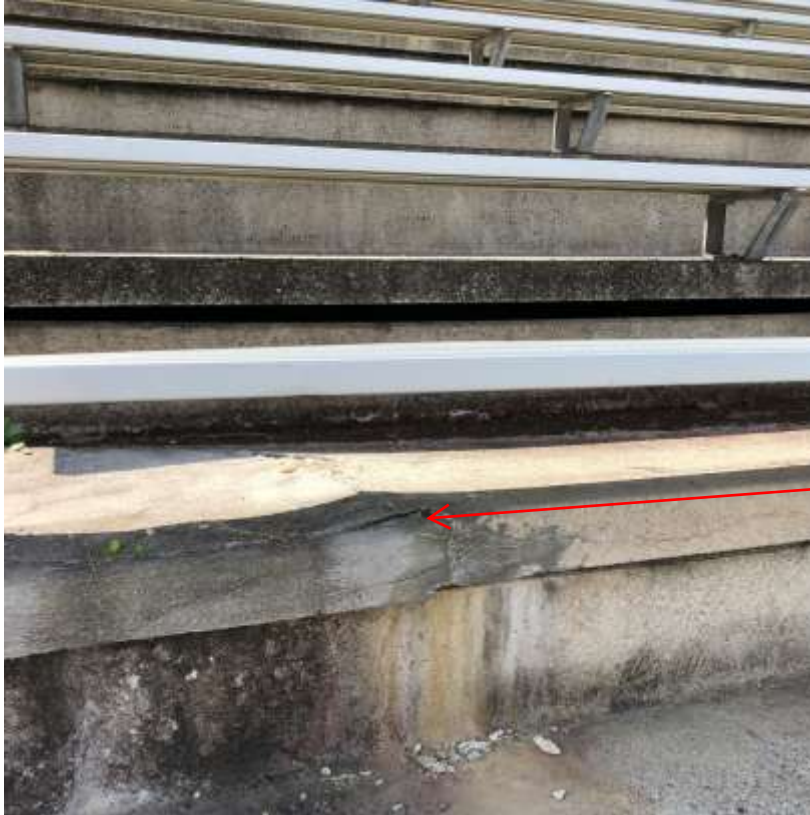
Photo 11

Crack/Kink in
precast concrete
beam

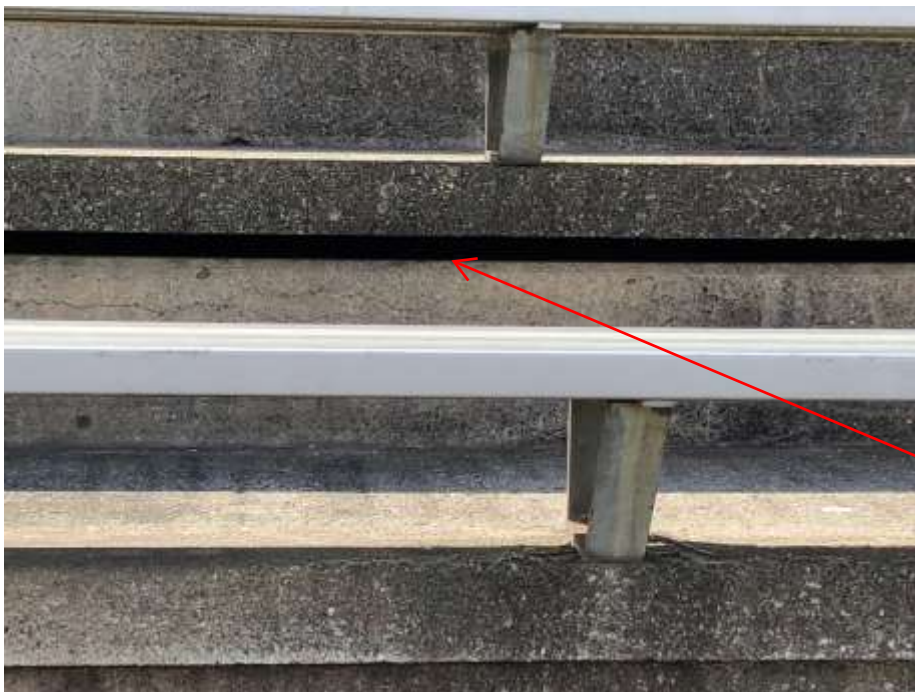
Photo 12

Deflection in
precast concrete
beam
