PROJECT Madison High School Stadium Renovations
FIELD REPORT

PROJECT Madison High School Stadium Renovations
PROJECT NO 0201-199620
CONTRACT
FIELD REPORT NO 002
DATE 01-18-2023
TIME 2:00pm
WEATHER Mostly Sunny
TEMP RANGE Mid 50's
PRESENT AT SITE Dr. Will Hoffman, Philip Cannady, Michael Jackson, Robyn Maynard, Ian Johnson, Scott Donald, Rob Stenhouse
DISTRIBUTION Dr. Will Hoffman, Philip Cannady, Michael Jackson, Chris Otahal, Ian Johnson, Scott Donald, Rob Stenhouse
REPORT BY Rob Stenhouse, Assoc. AIA

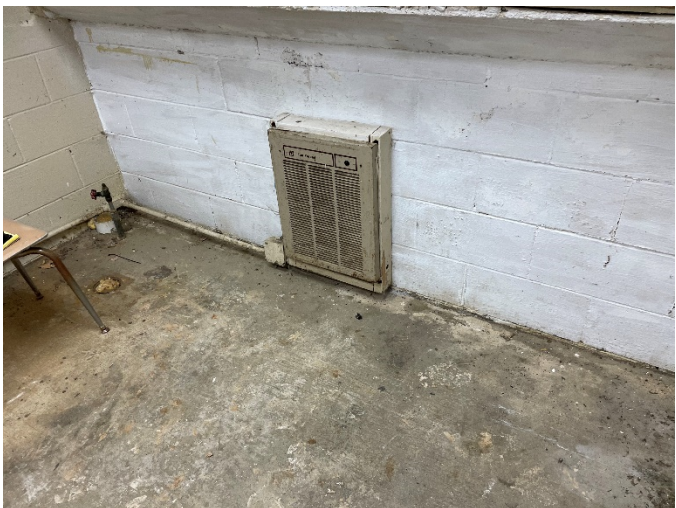
^ Existing Concessions floor, looking east

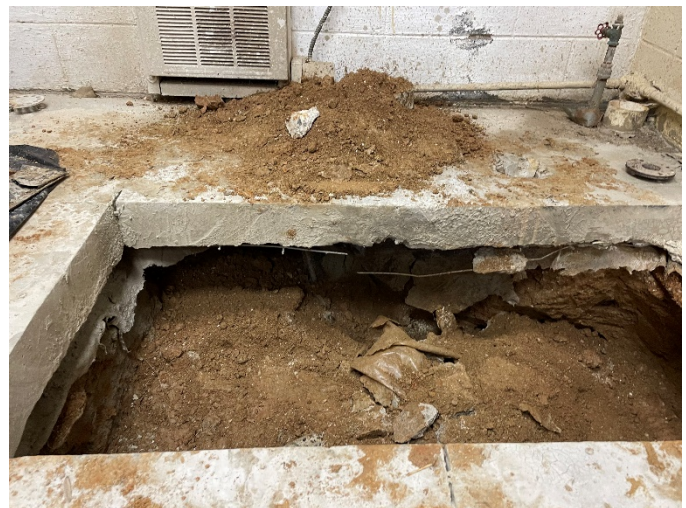
- Existing slab is undermined the full width of the Press Box Building. A bow in the existing slab is visible.
- Appears existing slab is not supporting existing walls and is poured between CMU walls. Verify with Structural Engineer if removing slab completely viable.
- With fill, additional cost projected to address press box slab field conditions, discussed removing the epoxy floor finish from the bathrooms and concession stand, leave as an exposed concrete surface.
- Work to cover retaining wall footing at Press Box remains – Estimate T & M Not To Exceed \$12,000.00 discussed. H&M discussed this temporary repair with Ian Johnson, PE of Kessel Engineering; Repair not as extensive as H&M projected, should cost less than anticipated.
- H&M / Dr. Hoffman to further investigate location of stadium light wire below grade at home side.
 - Locate stadium light connection wire on visitor side

^ Interior concessions slab cut – earth below eroded away looking west

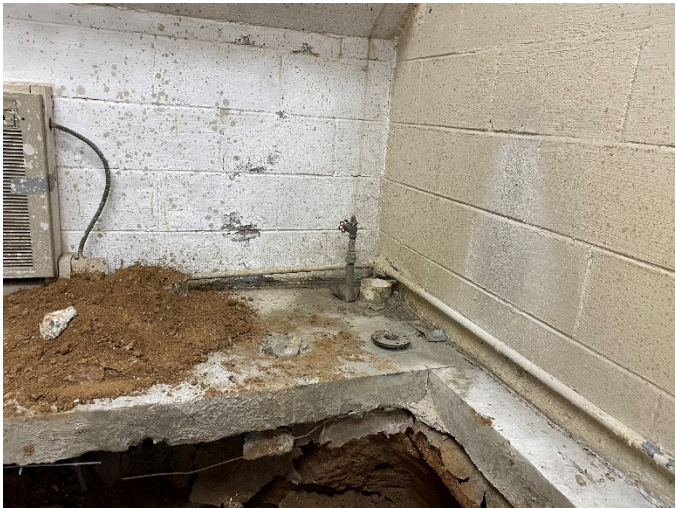
^ Slab cut, looking northwest

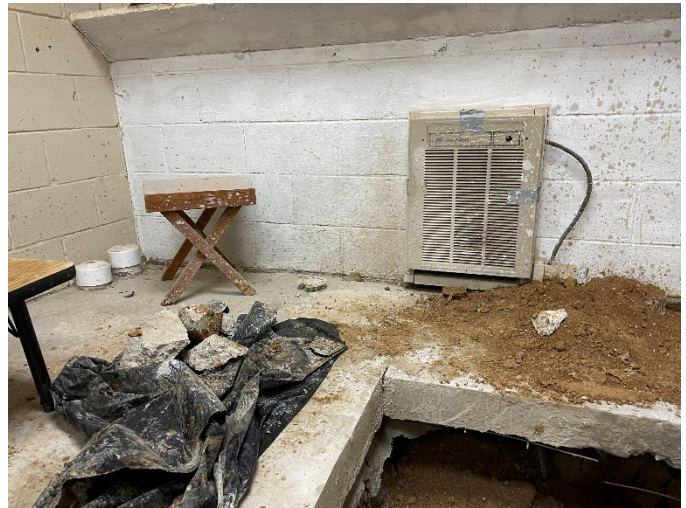
^ Slab cut, looking southwest

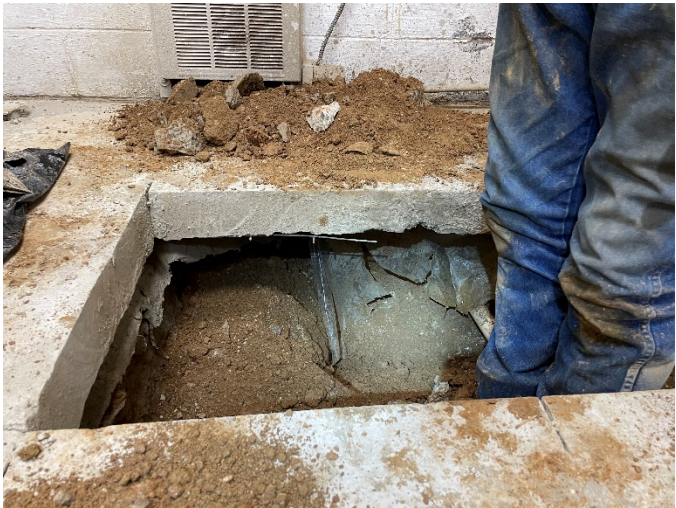
^ Press box/Concessions, foundation verified, looking west

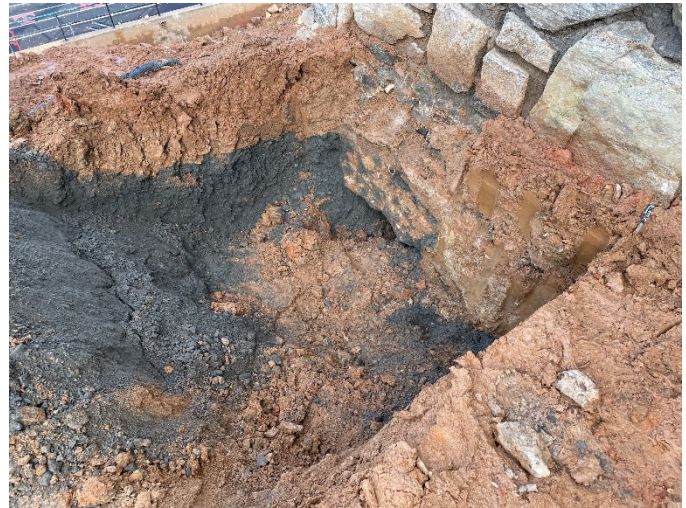
- Observations made at the demo'd home side grandstand.
 - More rubble removed from within the remaining Home side bleacher area
- Area to west of site being prepped for additional concrete crushing.
- H&M cut interior hole at Press Box to review interior below slab conditions.
 - Separate footing for North side press box wall found. Top Of Footing (3) courses below top of slab. This TOF (Press box only) 5" higher than existing TOF for retaining wall
 - Footing for west side of pressbox found. Top Of Footing (3) courses below top of slab (verify in field).
 - This footing has been undermined, visible from outside, and will need Structural Engineer remediation input. West stone veneer appears to not be supported on a footing, project same condition an east side.

^ Gap below stone veneer, this undermined earth is below existing foundation, stone appears to **not** rest on a footing

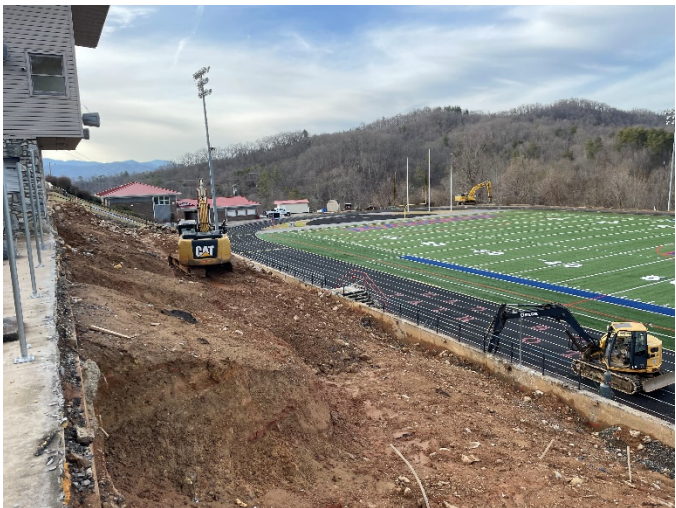
^ Overall homeside demolition view – existing rock steps to be demolished as well

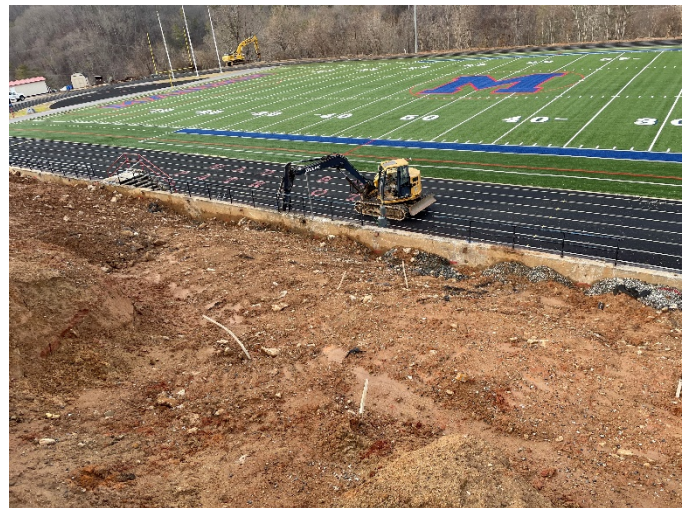
^ Rubble removed, existing grade – looking northwest

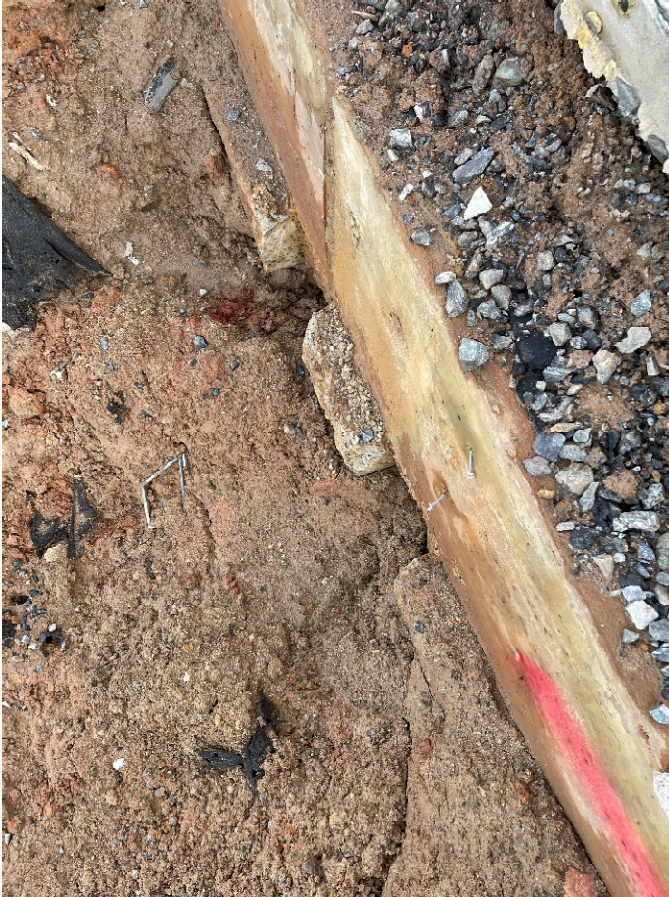
^ east side of upper retaining wall, existing erosion

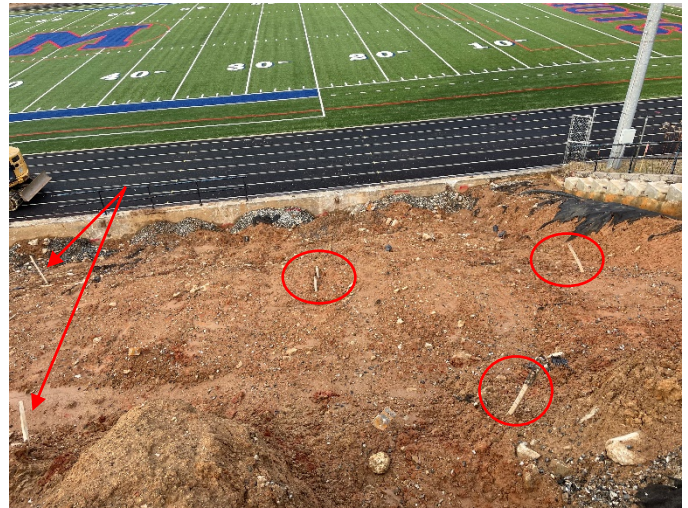
^ Rubble from within retaining walls removed, note helical piles. Appears these were placed to support precast planks

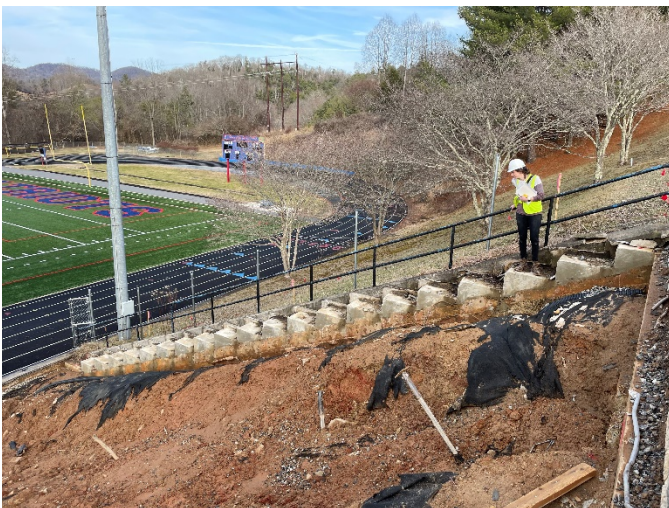
^ East raker beam to remain

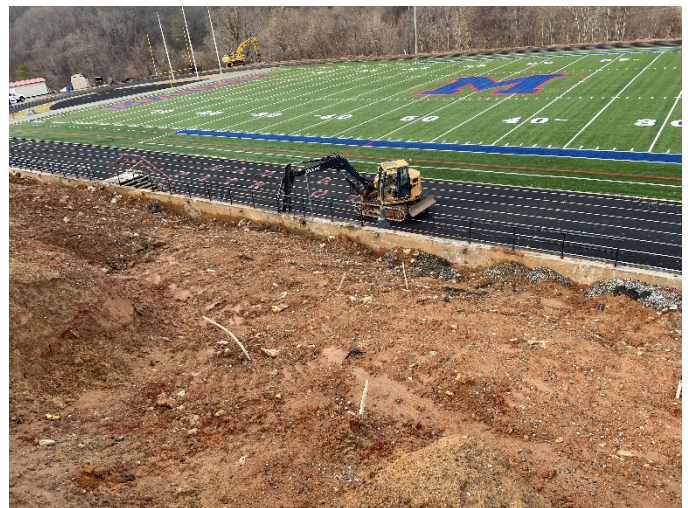
^ Rubble removed, existing grade – looking northwest
